NASA TN D-2884

DEVELOPMENT OF A HEMISPHERICAL METAL DIAPHRAGM FOR SINGLE-
CYCLE LIQUID-METAL POSITIVE EXPULSION SYSTEMS

By Sol Gorland

Lewis Research Center
Cleveland, Ohio

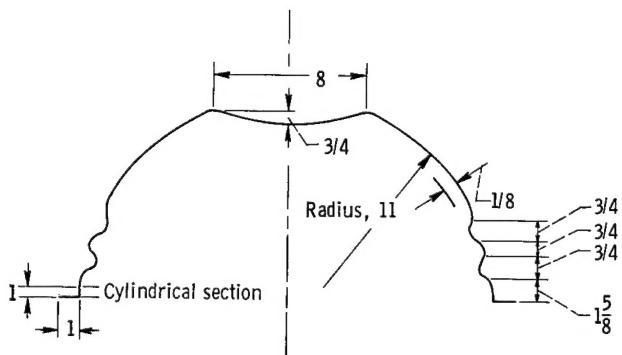
Figure 4. - Convoluted diaphragm. Configuration B. (All dimensions in inches.)

Configuration B consisted of a diaphragm containing a pair of corrugations that were spun onto the surface to allow easier rolling of the metal during expulsion as shown in figure 4. One 0.010-inch-thick configuration B diaphragm was fabricated.

In the fourth expulsion test, a 0.010-inch-thick hemisphere using configuration B (see fig. 4, p. 4) was tested. It was felt that the combination of the thinner material and the built-in convolutions would control the buckling and allow easier rolling of the metal thus possibly eliminating the double-fold-type deformation occurring at the cylindrical section of the diaphragm.

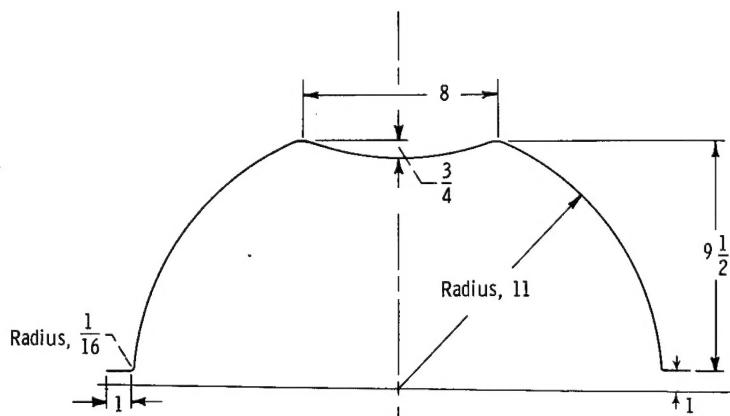
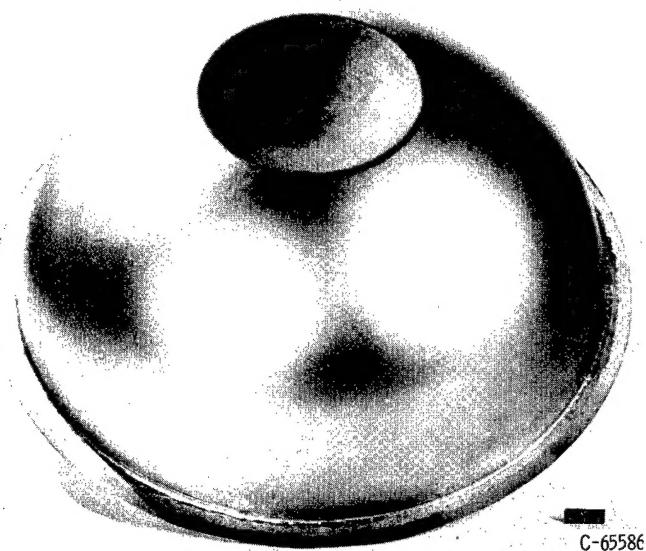
Figure 5. - Final segmented hemispherical diaphragm. Configuration C.

Configuration C was essentially another modification of configuration A. It consisted of removing the 1-inch cylindrical section and 1/2-inch of the hemispherical section of the diaphragm as shown in figure 5(a). A new 1-inch-wide flange was then welded to the original material (to replace the integral flange of configurations A and B) so that the diaphragm could be clamped in the containment sphere. The flange was silver soldered to waterproof the joint as seen in figure 5(b). Configuration C was slightly less than a hemisphere and is actually a "segment" of configuration A. Two 0.016-inch-thick configuration C diaphragms were fabricated. Figure 5 shows a photograph of a configuration C diaphragm. Although configurations A and B were slightly different, figure 5(b) is typical of the diaphragms and clearly shows the polar indentation common to all.

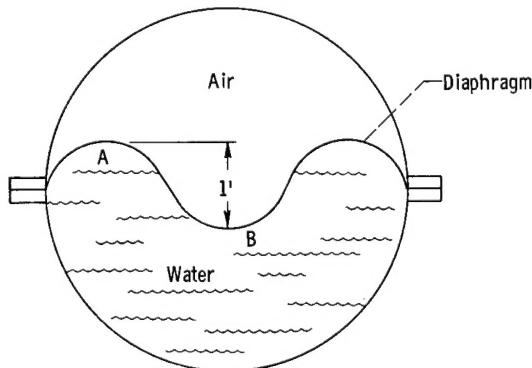
Figure 6. - Illustration of diaphragm deformation with air as pressurizing medium and water as expulsion medium.

The pressurization system as well as the test fluid was provided by city water lines capable of 60 pounds per square inch. Air had been considered as a pressurizing agent, to better simulate actual use, but this was decided against because of the unequal pressure forces on the expulsion side of the diaphragm resulting from the hydraulic head. Figure 6 illustrates that, with air as the pressurizing medium, the force at A would be less than at B because of the hydraulic head difference. Therefore, to simulate zero gravity, the same fluid was used as both the pressurizing medium and the expulsion fluid. This is not necessary in actual flight operation, and a gas pressurization system would be used.

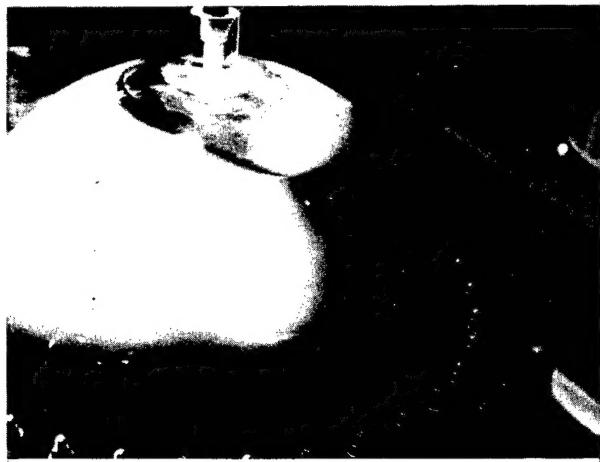
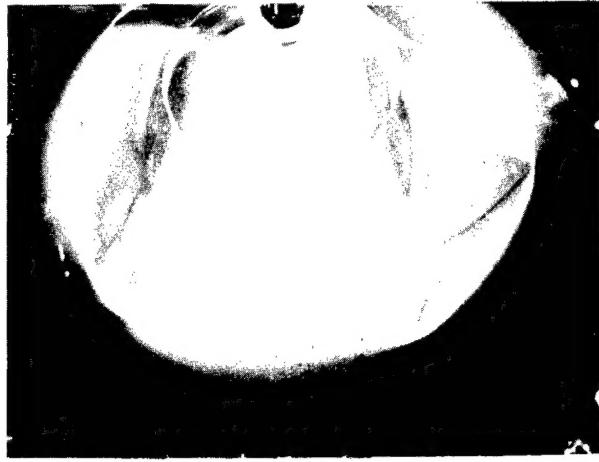
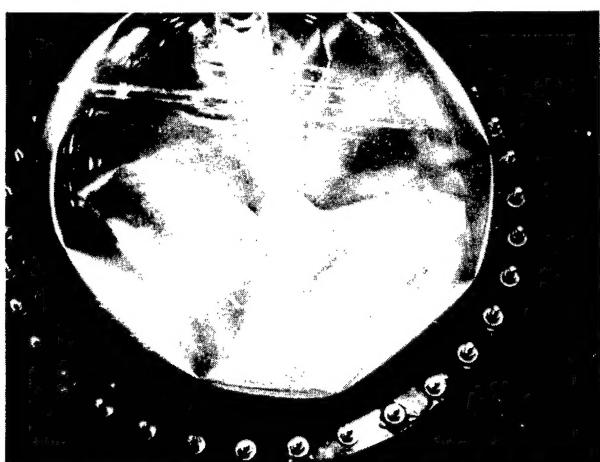
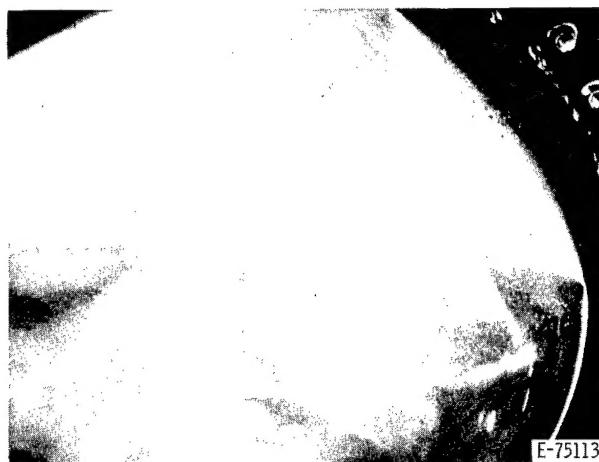
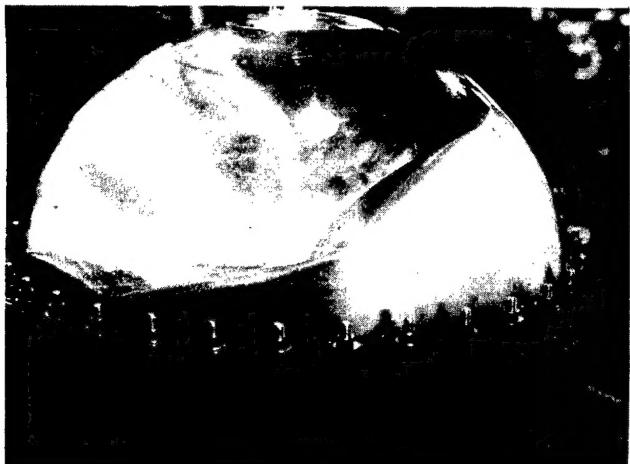
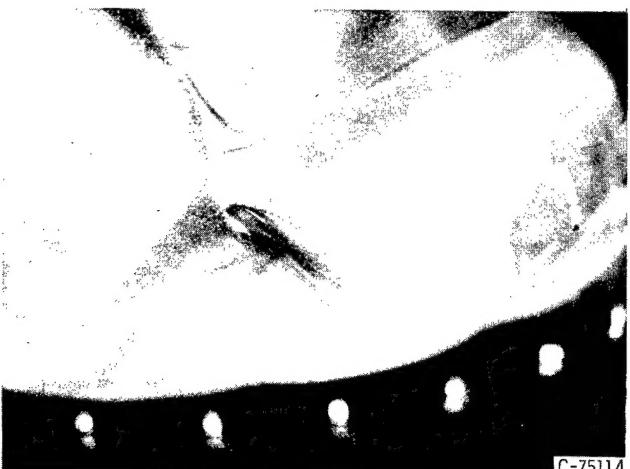
(a) Initial deformation showing asymmetry (2 percent expulsion).

(b) Sharp-edged cornering (5 percent expulsion).

(c) Pyramid-type deformation (15 percent expulsion).

(d) Pyramid-type deformation closeup (15 percent expulsion).

Figure 7. - Progressive deformation of diaphragm during expulsion cycle. Configuration A; test 1, 0.016-inch-thick diaphragm; flow rate, ~190 pounds per hour.

The first expulsion test was run as a shakedown for the experimental procedure and equipment. The flow rate as shown in table I was 190 pounds per hour. Deformation of the diaphragm began at an applied pressure of approximately 4 pounds per square inch. As shown in figures 7(a) and (e), deformation was unsymmetrical. A cornering effect started almost immediately, as seen in figure 7(b), but it did not seem to hinder deformation. Deformation took the form of a triangular pyramid-type deflection shown in figures 7(c) and (d). As the diaphragm neared the cylindrical section at the flange area, a double-fold-type deformation developed, which was typical of all the diaphragms tested. This is seen in figure 8 at a percent expulsion of approximately 60 percent. At approximately 65 percent expulsion, recycling was attempted to test the cycle capability of the diaphragm. Immediately, a torsional-type deformation developed (fig. 7(f)), similar to the twisting of a roll of paper. If recycling had continued, failure of the diaphragm would have occurred because of the severe twisting action, so the direction of expulsion was again reversed until approximately 85 percent of the original volume was displaced.

The diaphragm developed a leak at approximately 70 percent expulsion, but since this was a shakedown run it was decided to continue the test beyond initial failure to study the deformation process. Upon removal, the diaphragm was found to have torn at one of the double folds. Figure 9 shows the first diaphragm after removal from the containment sphere; the tear at the double fold is circled.

(e) Assymmetry of deformation (25 percent expulsion).

(f) Three corner fold as a result of torsional deformation (65 percent expulsion).

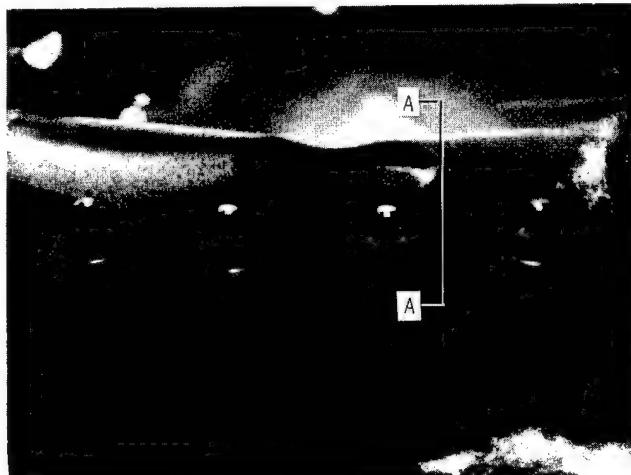
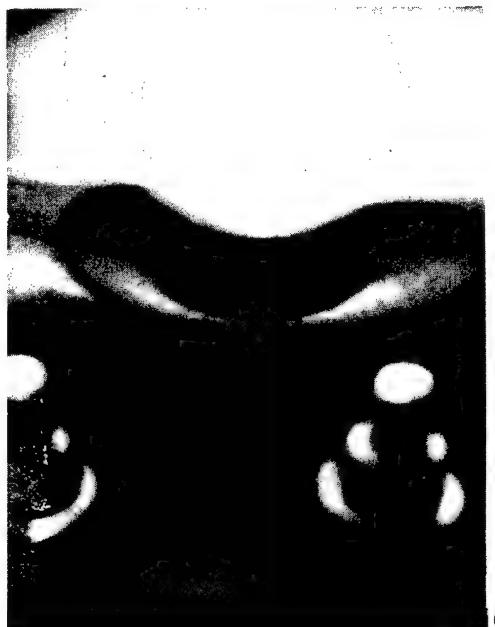
(a) Double fold in diaphragm.

(b) Closeup of double fold.

Figure 8. - Typical double fold. Configuration A, test 1; 0.016-inch-thick diaphragm (60 percent expulsion).

Failure occurred, as previously, at a double fold. The dye made it possible to determine the moment of failure, so that the flow could be stopped, but a more dilute dye was necessary for photographic purposes. As shown in table I, the percent expulsion of the second diaphragm at the time of failure was 76.5 percent.

An expulsion diaphragm should be designed so that during the expulsion cycle, folding or doubling back of the material is avoided. This was done in this investigation by eliminating the regions within the diaphragm where 180° folds were necessary.

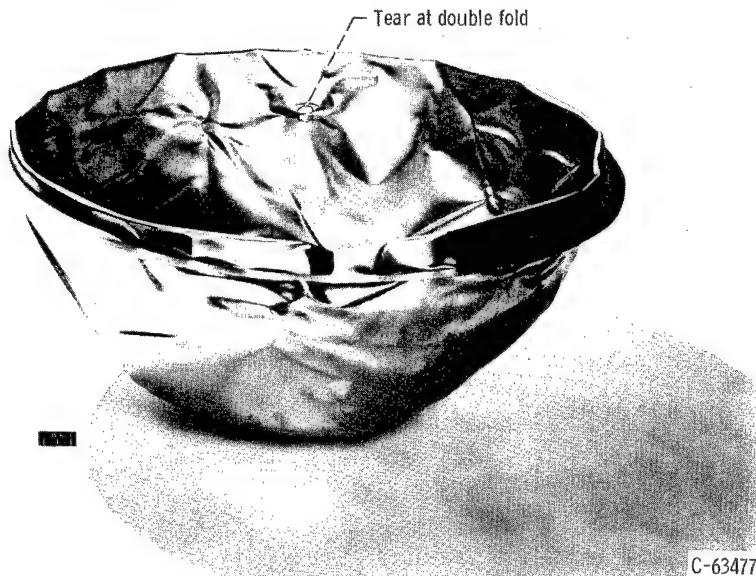
Figure 9. - Diaphragm configuration A at end of test 1 (85 percent total expulsion tear occurred at 70 percent expulsion).

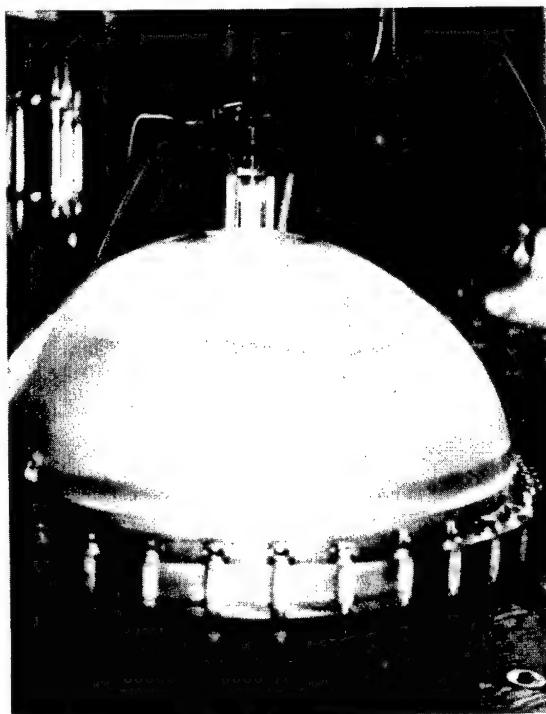
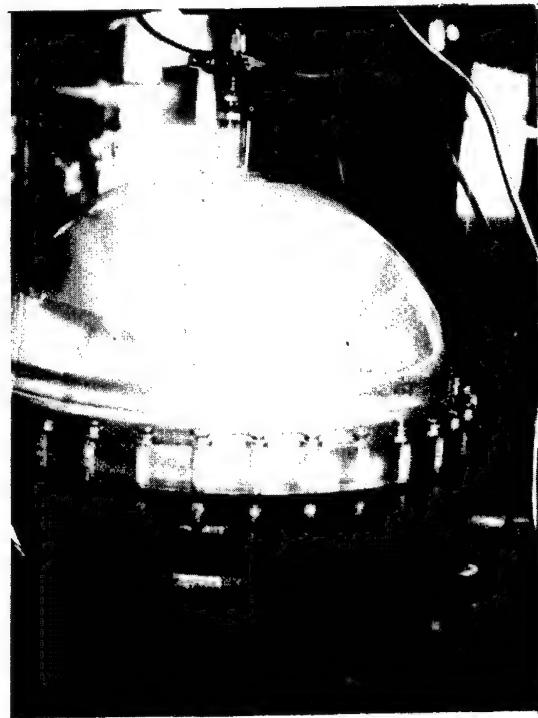
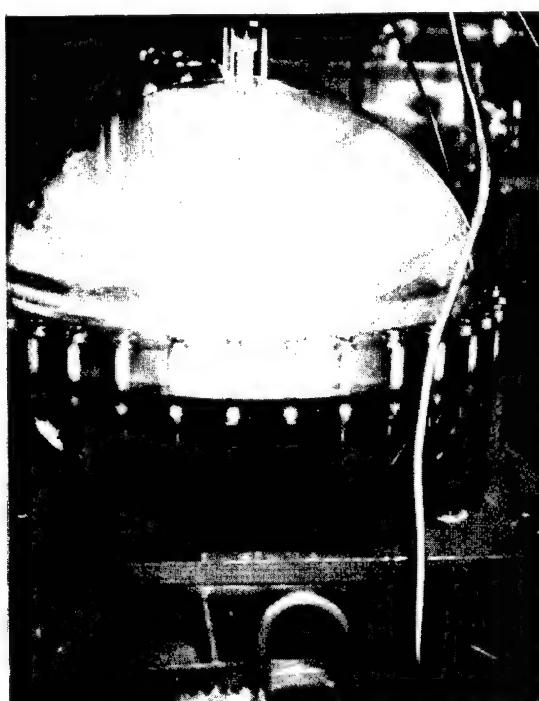
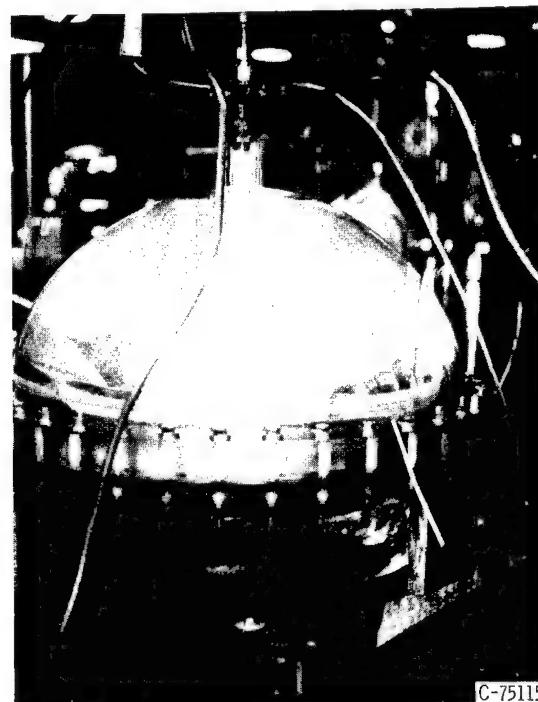
The corrugated hemisphere initially deformed very uniformly as shown in figure 10(a). It then began to deform on one side until the first or upper corrugation was reached. As seen in figure 10(b), it appeared that the material would easily roll over the corrugation, but cornering occurred in the corrugated area (fig. 10(c)). Columns formed in the corrugated areas (fig. 10(d))

(a) Initial deformation of corrugated diaphragm (5 percent expulsion).

(b) Deformation nearing first corrugation (25 percent expulsion).

(c) Cornering effect in first corrugation (35 percent expulsion).

(d) Column formation in first corrugation (50 percent expulsion).

Figure 10. - Progressive deformation of diaphragm. Configuration B; test 4; 0.010-inch-thick diaphragm; flow rate, 205 to 235 pounds per hour.

supporting the hemisphere on that side until deformation was symmetrical. The second corrugation then became the starting point for the double fold phenomenon seen in figure 10(d). When this condition was attained, nearly the entire surface within the first corrugation seemed to double fold at once. Six double folds occurred almost simultaneously, all of which were larger than in the previous hemispheres. Three of these double folds produced tears at the failure point of 60.2 percent expulsion.

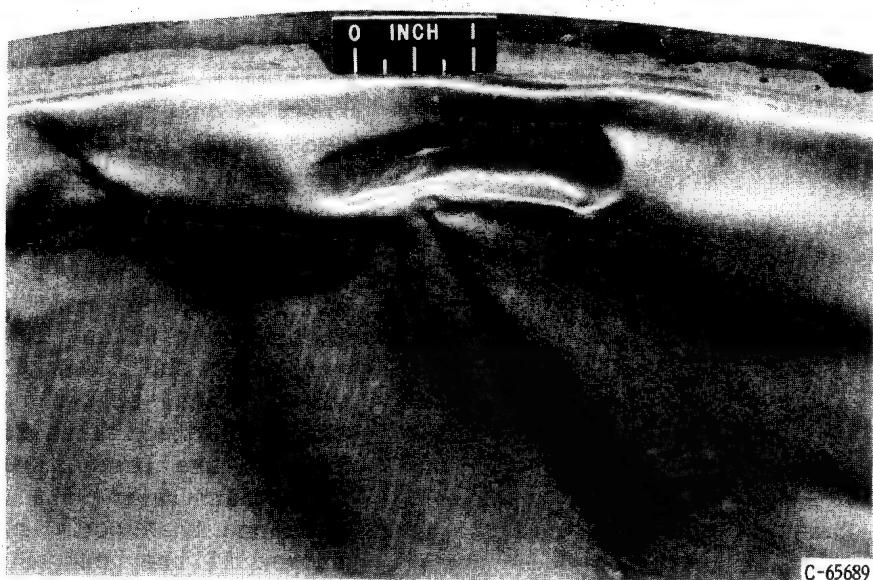
Figure 11. - Fully formed double fold in diaphragm configuration C after completion of expulsion cycle, 0.016-inch-thick diaphragm (95 percent expulsion, test 7).

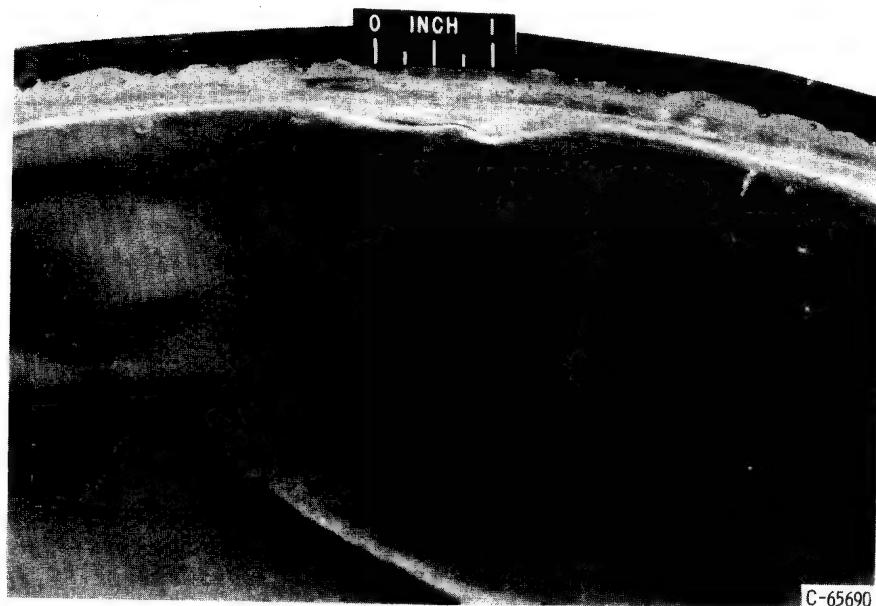
Figure 12. - Double fold at flange joint in diaphragm configuration C after completion of expulsion cycle, 0.016-inch-thick diaphragm (95 percent expulsion, test 7).

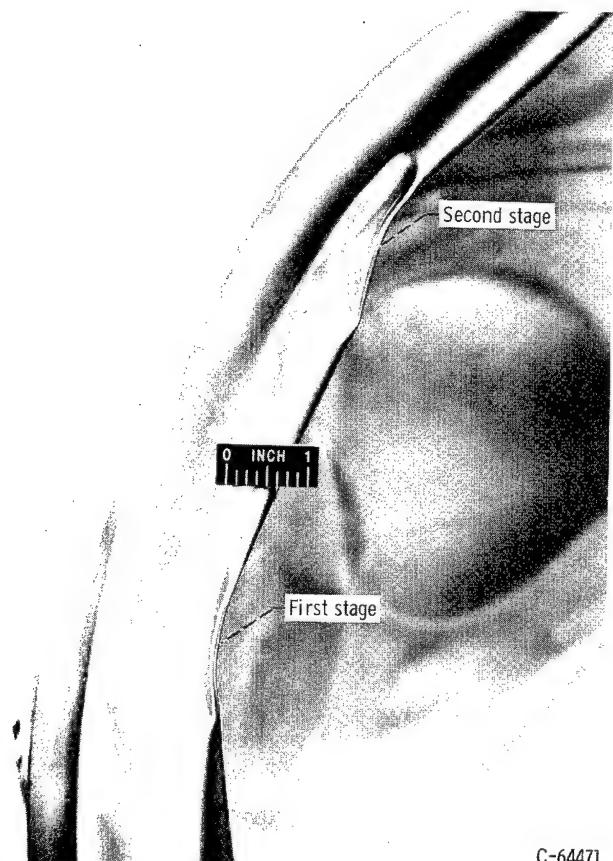
The third expulsion test again attempted to get motion pictures and also run the test at a higher flow rate. Failure again occurred at a double fold, the formation of which was similar to that for the other lower flow rates. The test was stopped when a hole developed in the diaphragm at an expulsion of 63.4 percent. Failure occurred earlier in the expulsion cycle than previous tests at lower flow rates. Films of this test clearly showed the method of deformation and the double fold phenomenon, which caused failure. These films aided in the visual analysis of the problem of diaphragm failure.

Figure 13. - Progressive stages of double folds in diaphragm. Configuration A; test 3.

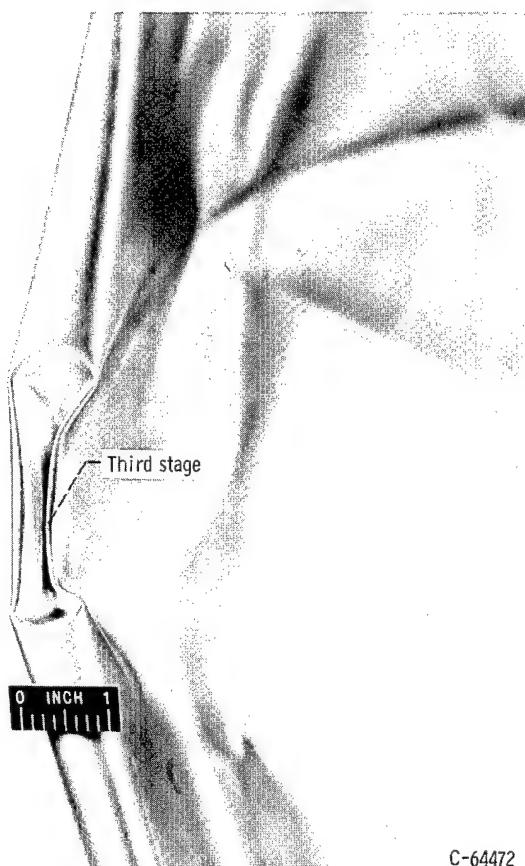
Figure 14. - Fully formed double fold in diaphragm. Configuration A; test 3.

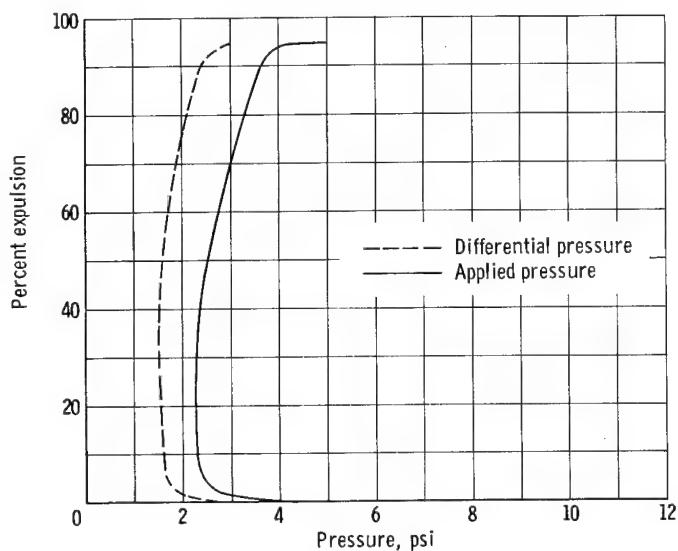
Figure 15. - Typical percent expulsion against pressure.

The pressure and deformation characteristics of the diaphragm can be discussed in a general manner since all the diaphragms performed similarly in this respect. A curve of percent expulsion plotted against applied and differential pressure, which was typical for all the diaphragms tested is shown in figure 15. After the initial deformation, the applied pressure decreased rapidly during the first 2 percent expulsion. The deformed area was increasing at a rate such that the load per lineal inch on the perimeter of the deformed surface was nearly constant with the decrease in applied pressure. Typical deformation up to this point would appear as in figure 7(a). The arch-type bulges formed during deformation give strength to the diaphragm and when one of these buckled (at approximately 5 percent expulsion), a sharp pressure drop resulted. Decreased structural strength and the larger deformed area allowed the diaphragm to deform at an increased rate, thus increasing the flow rate. Typical deformation at this point would appear as it does in figure 7(b) (p. 7). Deformation continued at essentially constant pressure until approximately 40 percent expulsion, when the factor of increased force necessary to roll the material over itself overcame the increase in deformation area and the applied pressure began to increase. As shown in the curve of figure 15, this gradual increase in pressure continued until approximately 95 percent expulsion, if failure did not occur. Beyond approximately 95 percent expulsion, a
